Passive Infrared Thermography—A Qualitative Method for Detecting Moisture Anomalies in Building Envelopes

Key words: Infrared Thermography, Building Envelope, Moisture Evaluation, Mold, Fungi

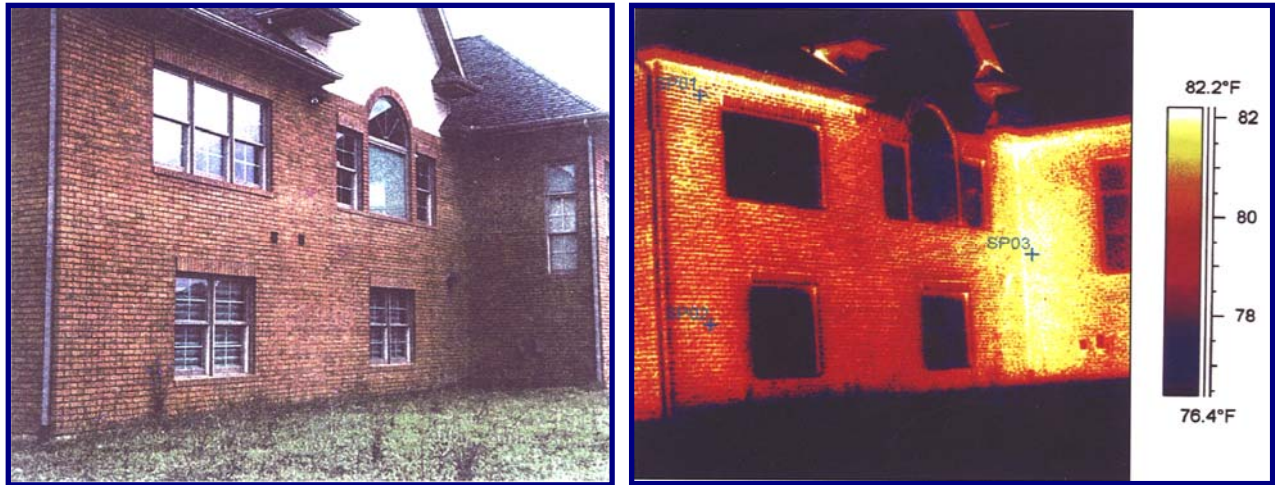
Figure 2. This thermographic image taken at the south side of the north elevation on June 25 showed thermal anomalies in the brick veneer. The suspected wet areas are relatively warm and clearly visible in this thermogram as white and yellow areas. Cooler, dry areas are red, purple, and black. The color bar shows the measured temperature range of 76.4 to 82.2 °F. The ambient temperature was 76 °F and the object distance was 50 ft. See Figure 4 for observations made during the intrusive inspection of the wall cavity.

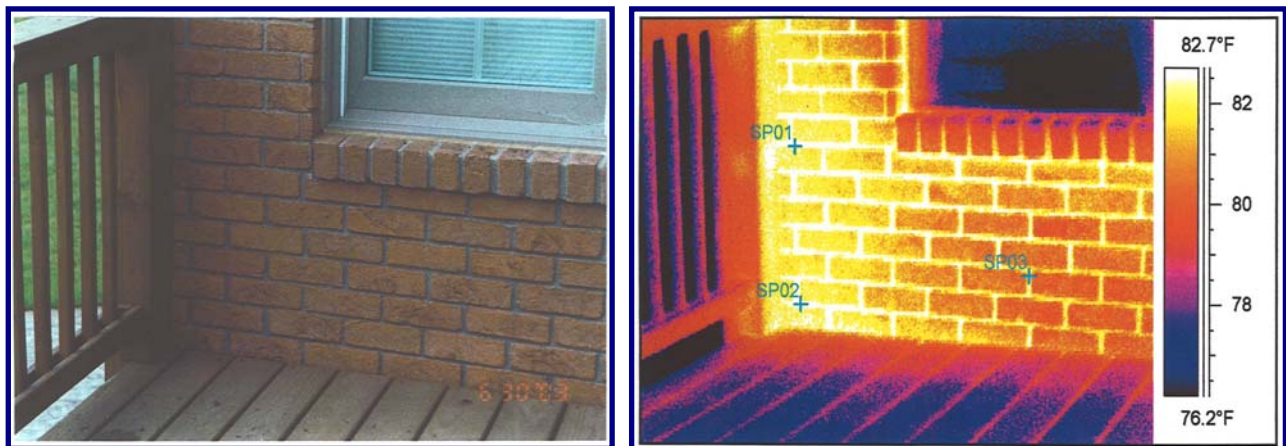
Figure 3. This thermographic image taken at the south end of the north elevation on June 25 showed thermal anomalies in the brick veneer. The suspected wet areas are relatively warm and clearly visible in this thermogram as white and yellow areas. Cooler, dry areas are pink, purple, and black. The color bar shows the measured temperature range of 76.2 to 82.7 °F. The ambient temperature was 76 °F and the object distance was 6 ft. See Figure 5 for observations made during the intrusive inspection of the wall cavity.

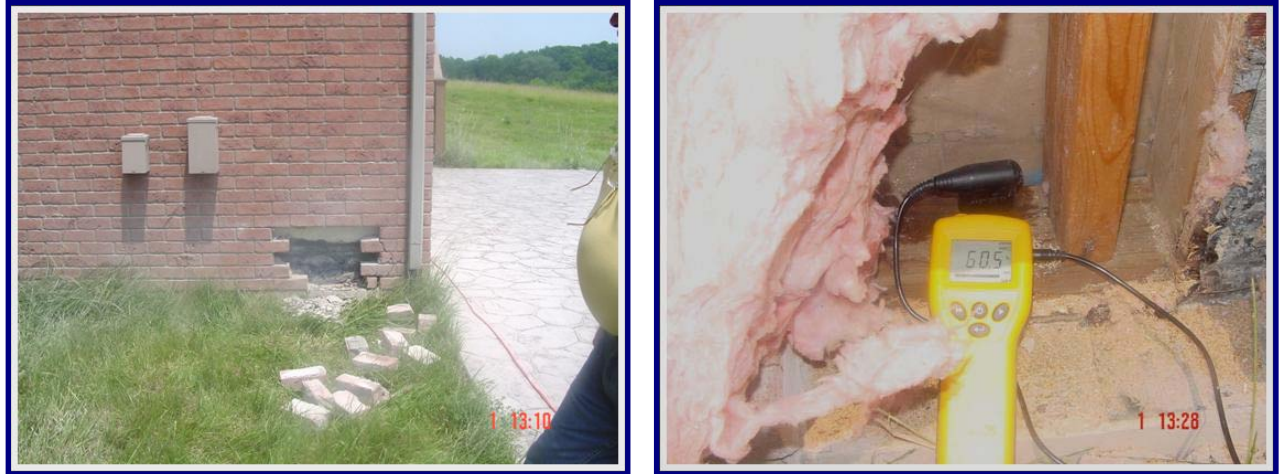
The inspection concluded that the moisture gained access through capillary action at the various openings in the exterior (i.e., windows, etc.) and that the water shedding ability or weatherproofing of the mortar and brick had been compromised by excessive acid cleaning of the masonry. Further, the presence of moisture within the wall cavities is attributable to improper installation of the brick veneer.

Figure 4. Intrusive inspection of the wall cavity at the south side of the north elevation; see corresponding thermogram in Figure 2. Elevated moisture levels were measured in the building materials. Fiberglass batt insulation was colonized by fungi (18,680 CFU/g) and was dominated by *Aspergillus versicolor* (91%).

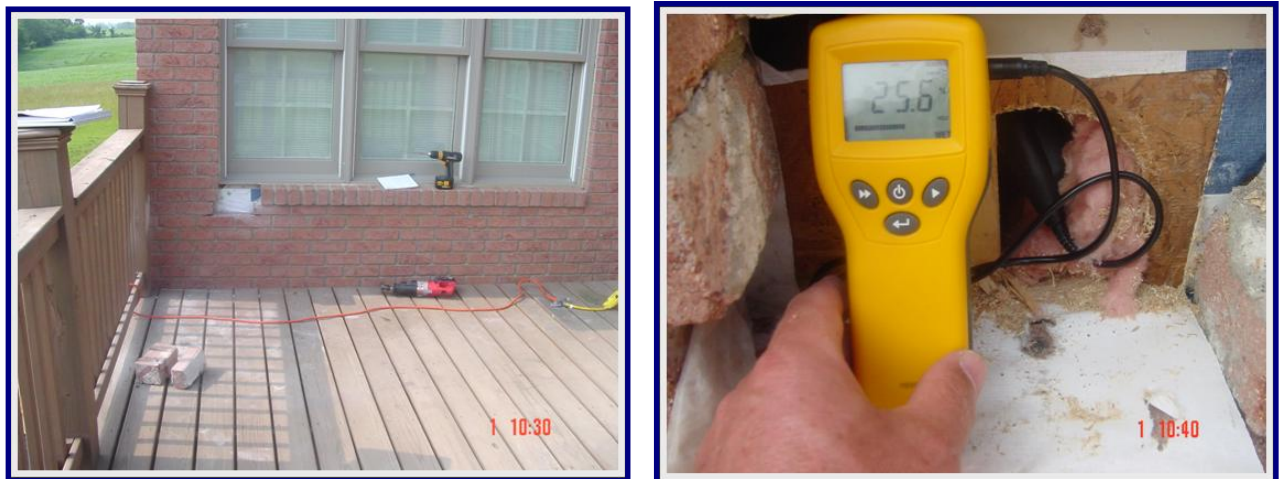
Figure 5. Intrusive inspection of the wall cavity at the south end of the north elevation; see corresponding thermogram in Figure 3. Elevated moisture levels were measured in the building materials. Fiberglass batt insulation was colonized by fungi ($9.71E+05$ CFU/g) and was dominated by *Acremonium strictum* (76%) and *Aspergillus versicolor* (22%).

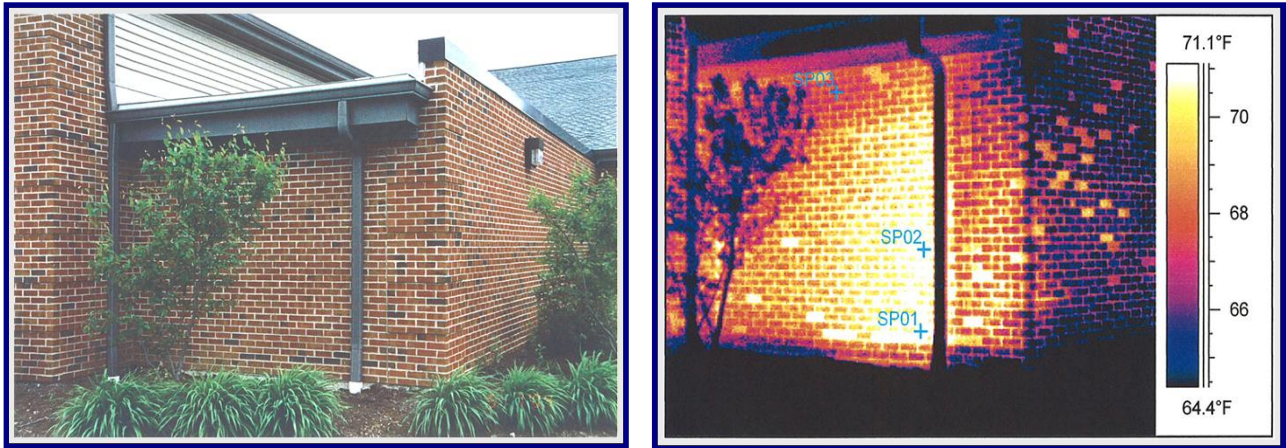
Figure 6. This thermographic image taken at the southeast elevation on April 16 showed thermal anomalies in the brick veneer. The suspected wet areas are relatively warm and clearly visible in this thermogram as white and yellow areas. Cooler, dry areas are pink, purple, and black. The color bar shows the measured temperature range of 64.4 to 71.1 °F. The ambient temperature was 73.4 °F and the object distance was 10 ft. See Figure 8 for observations made during the intrusive inspection of the wall cavity.

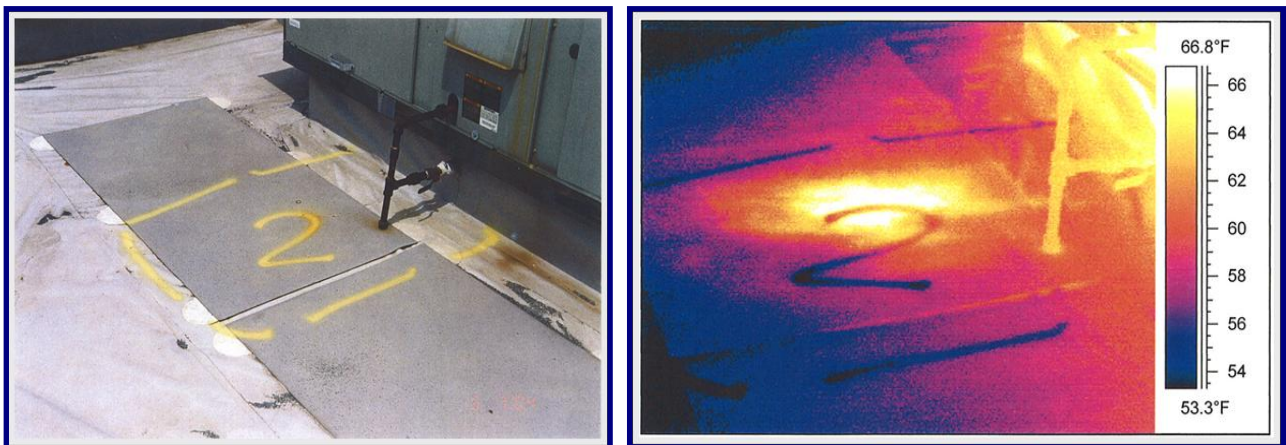
Figure 7. This thermographic image was taken of a section of the roof on April 16. A leak in the roof membrane allowed overflow moisture from the air-handling unit to enter the roofing system, resulting in roof-entrapped moisture. The suspected wet areas are relatively warm and clearly visible in this thermogram as white and yellow areas. Cooler, dry areas are pink, purple, and black. The color bar shows the measured temperature range of 53.3 to 66.8 °F. The ambient temperature was 73.4 °F and the object distance was 2.3 ft. The location of the finding is marked on the roof.

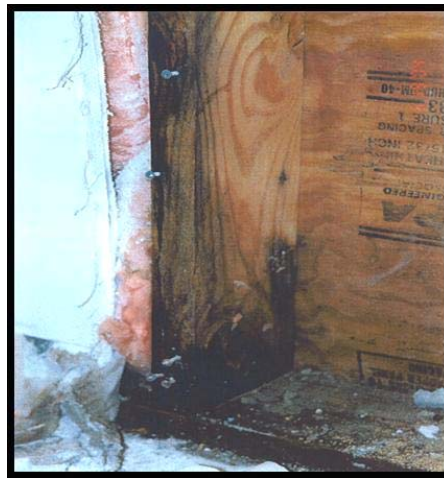
At the location shown in Figure 6, the intrusive inspection of the building envelope was conducted from the interior of the structure. A section of gypsum wallboard was removed to expose the vapor retarder, batt insulation, framework, and backside of the plywood sheathing (Figure 8). The lower portion of the gypsum wallboard was saturated with moisture and broke when handled. The presence of a mold-like substance was present on the lower 4 inches of the gypsum wallboard. Visible condensation was observed on the insulation side of the vapor retarder. Prior to removal of the insulation, a moisture measurement made of the batt insulation showed a reading of 22% wood-moisture equivalent. The 2 x 6 framing member was wet and water-stained, as was the sill plate (Figure 8). The excessive moisture caused the sill anchorage to corrode.

Figure 8. Water staining of framing members.

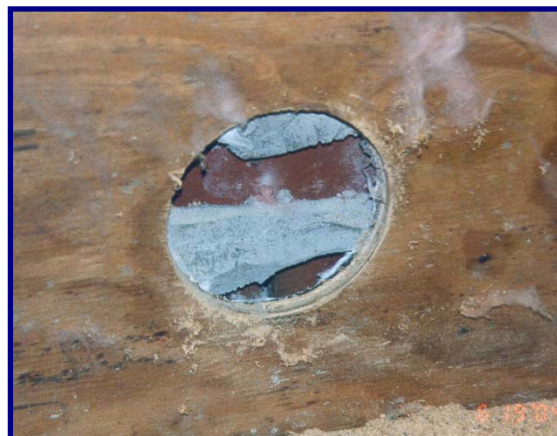
Because the masonry was not removed from the exterior, a 4-inch-diameter hole was cut in the exterior plywood sheathing just above the membrane flashing (Figure 9). The view (Figure 9) shows that the band of mortar running horizontally would obstruct the flow of water to the base flashing. The cavity between the brick and sheathing is $<1/2$ -inch and was found to be occluded. The brick veneer should be installed with a minimum of a 1-inch airspace.⁵ This air space must be clear of mortar and should be open at the top of the brick veneer wall, as well as at its base.

Figure 9. The band of mortar running horizontally would obstruct downward migration of moisture to the flashing and not be expelled to the exterior.

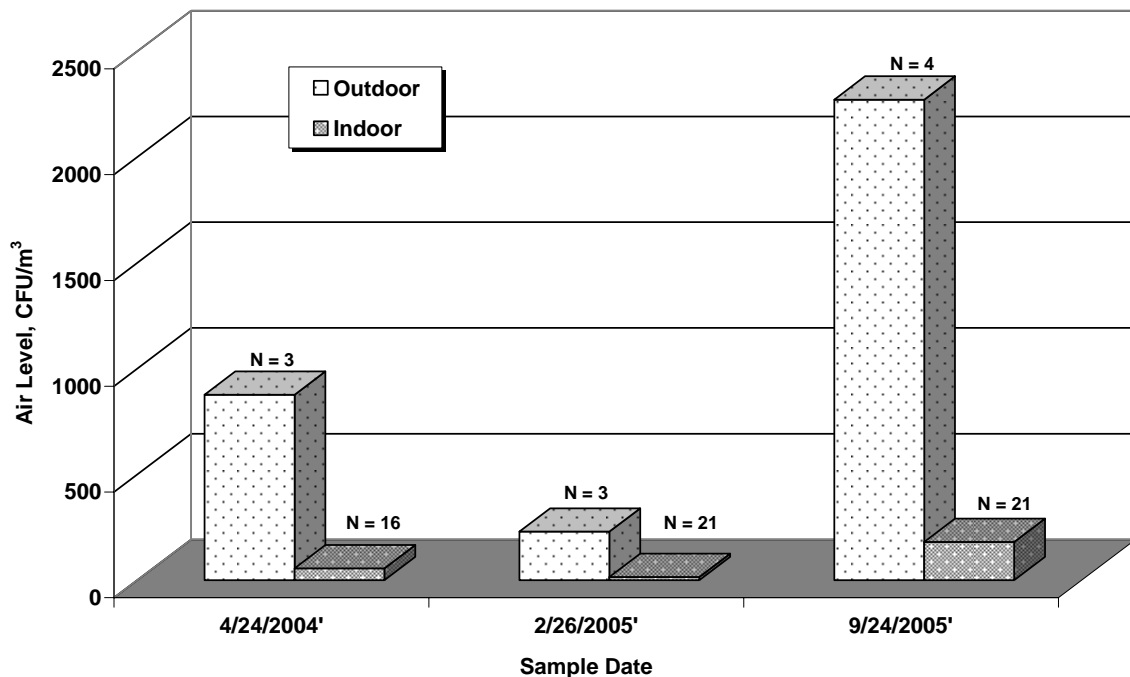
The average concentration of airborne culturable fungi measured outdoors was consistently higher than that present indoors (Figure 10). The indoor-to-outdoor ratio of total culturable fungi was consistently <0.1. The dominant fungi present outdoors were qualitatively similar to those present indoors. Typically, the normal air mycoflora outdoors are quantitatively higher than that indoors (i.e., indoor-to-outdoor ratio <1) if the primary source of the fungi is the outdoor air. This data suggests that the fungal colonization of the interstitial wall space is not migrating into the occupied space or has not been detected by these three sampling events.

Figure 10. Average airborne level of total culturable fungi in occupied space.
